Underwater Archaeology Branch

1981

**Excavation of a
Fort Fisher
Bombproof**

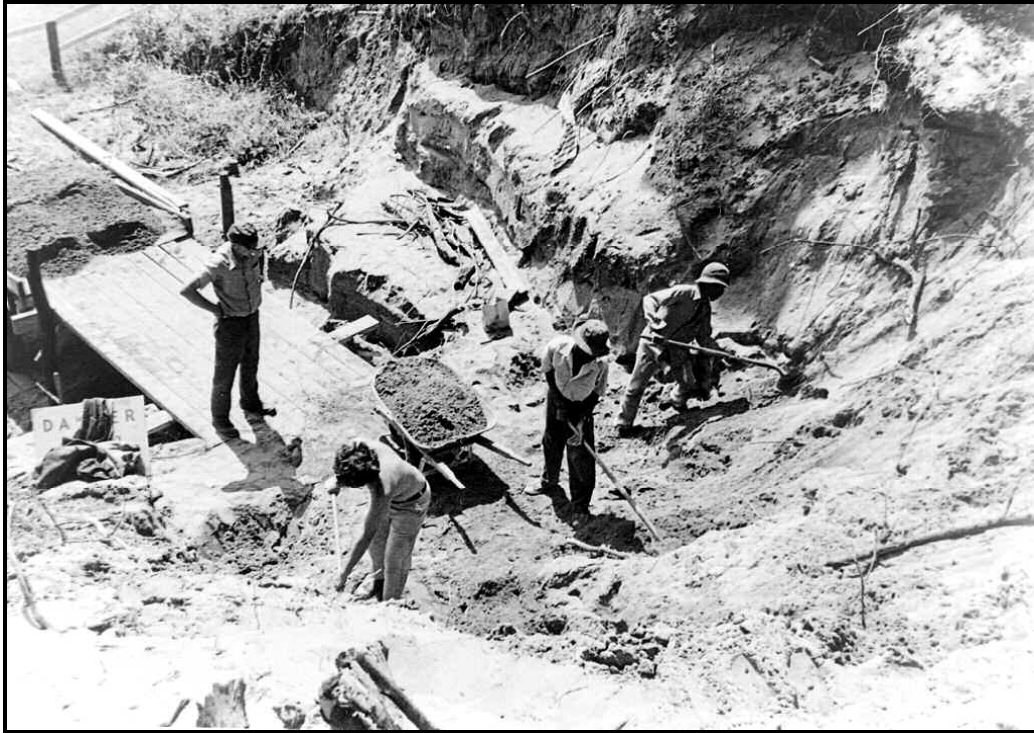
Figure 4: Prior to the availability of mechanical assistance, all overburden was removed by hand. A platform constructed over the bombproof entrance served both to protect the structure and facilitate loading a dump-body trailer designed by Fort Fisher State Historic Site.

Overburden in each excavated 10-foot by 10-foot grid square was removed by shovel until contact was made with identifiable portions of the structure. Trowels were then employed in exposing the remains for photographing and recording. As the investigation proceeded into the traverse, additional effort was required to dispose of overburden, and both terraces and shoring were employed to prevent sand from collapsing into the work area. The difficulties of working in the unstable sand eventually necessitated abandoning the excavation of grid squares associated with the topographic survey, and structural data was recorded in reference to a grid-associated baseline outside the confines of the excavation. Throughout the excavation of the entrance tunnel, the work proceeded in cycles. Overburden was removed to permit a section of approximately eight feet of the tunnel roof to be exposed. The tunnel roof was photographed, recorded, and plotted. The tunnel walls and sills were then exposed in cross section every 2 feet for photographing, recording, and plotting. Once this was complete, the exposed structure was protected by the construction of a work platform and additional overburden was removed to permit the exposure of the next segment of the structure. At a point approximately 12 feet from the room, this technique was abandoned because of the volume of overburden and lack of adequate protection offered by the construction of shoring. To expose the remainder of the structure a mobile crane equipped with a clamshell bucket was twice employed to remove sufficient overburden to permit the construction of adequate shoring. With the site stabilized and a large work area accessible, grid squares were reestablished to facilitate recording and the structure was exposed, photographed, documented, and plotted. With the excavation completed, fill dirt was brought in and the mound reconstructed according to the original topographic survey.

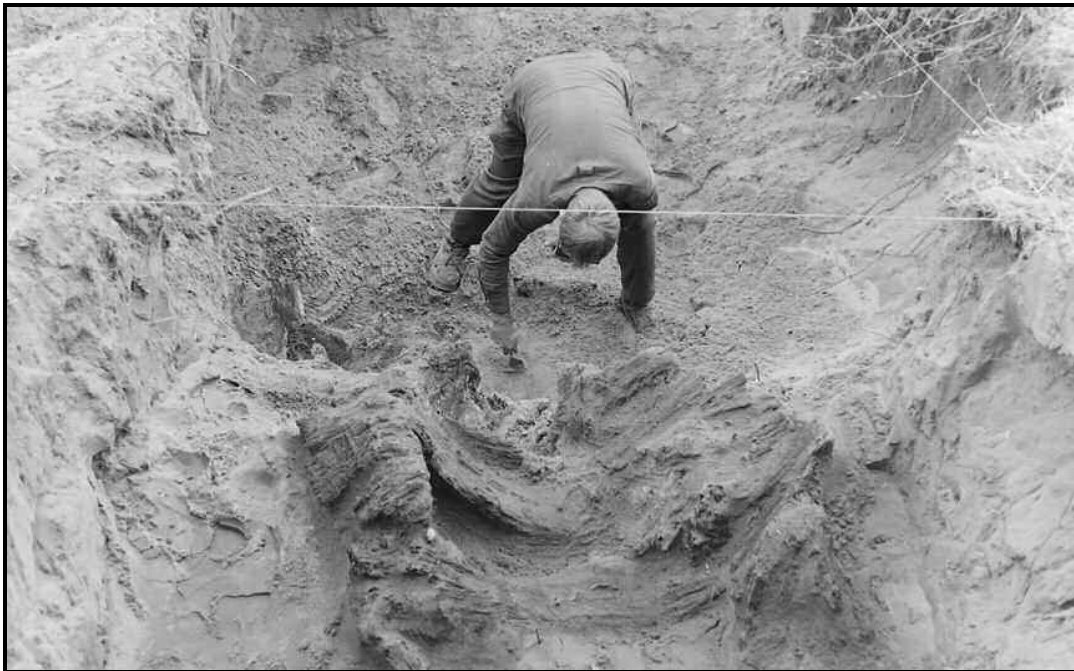
Figure 7: Along the entrance badly deteriorated remains of the roof were found to have sagged but survived to preserve structural data.

Two major factors affected the condition and structural integrity of wooden components of the tunnel and bombproof room. The first factor was the burning and subsequent collapse of portions of the structure shortly after the Civil War. The second was the natural deterioration and compression of the wood after being buried for 110 years. Along the length of the entrance tunnel, structural evidence was found to be in good condition in spite of both extensive fire damage and deterioration of the remaining wood. While random roof planks were found to have collapsed into the tunnel, the

majority remained intact, sagging into the tunnel. Framing the entrance, studs, corner posts, and side planking remained basically in their original positions. At the baffle, planking on the south and north walls had collapsed into the structure, but each of the corner posts and studs remained intact. As was the case in the entrance section, random roof planks were found to have collapsed into the tunnel while the majority only sagged. In the tunnel section immediately inside the baffle the entire roof was found to have dropped approximately ten inches, although it remained structurally intact. Walls in this section had shifted toward the baffle along the longitudinal axis of the structure but remained vertical. The interior planking survived intact for at least nine feet inside the baffle.

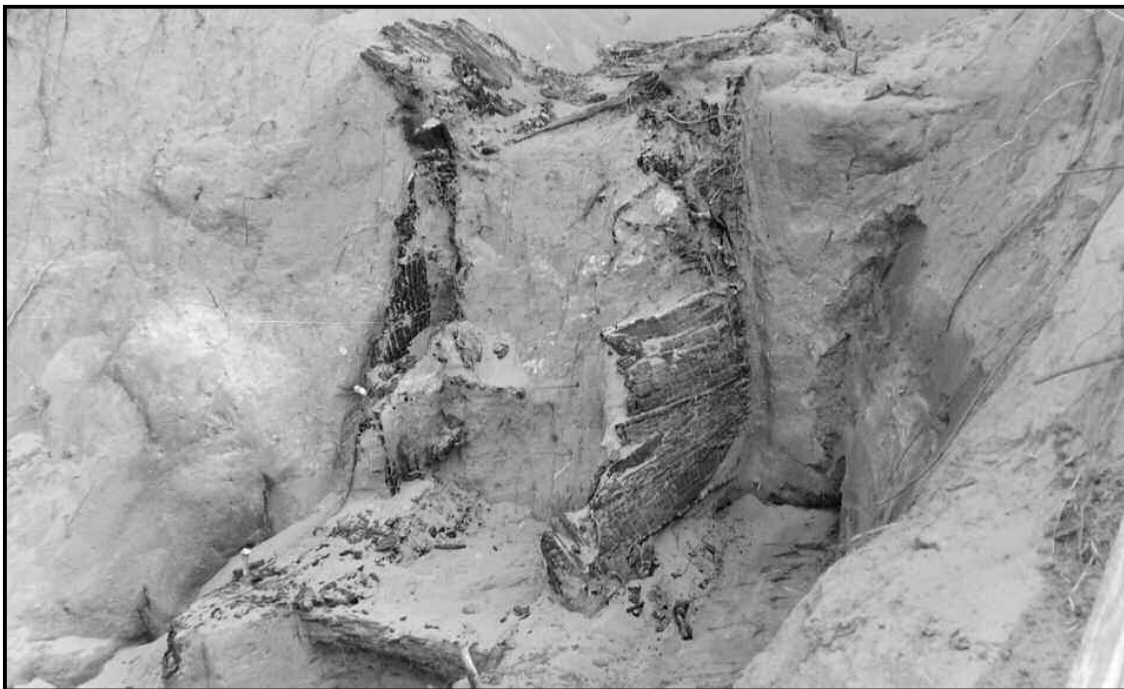
Figure 8: Although partially collapsed, the tunnel structure preserved an extensive record of architectural and construction details.

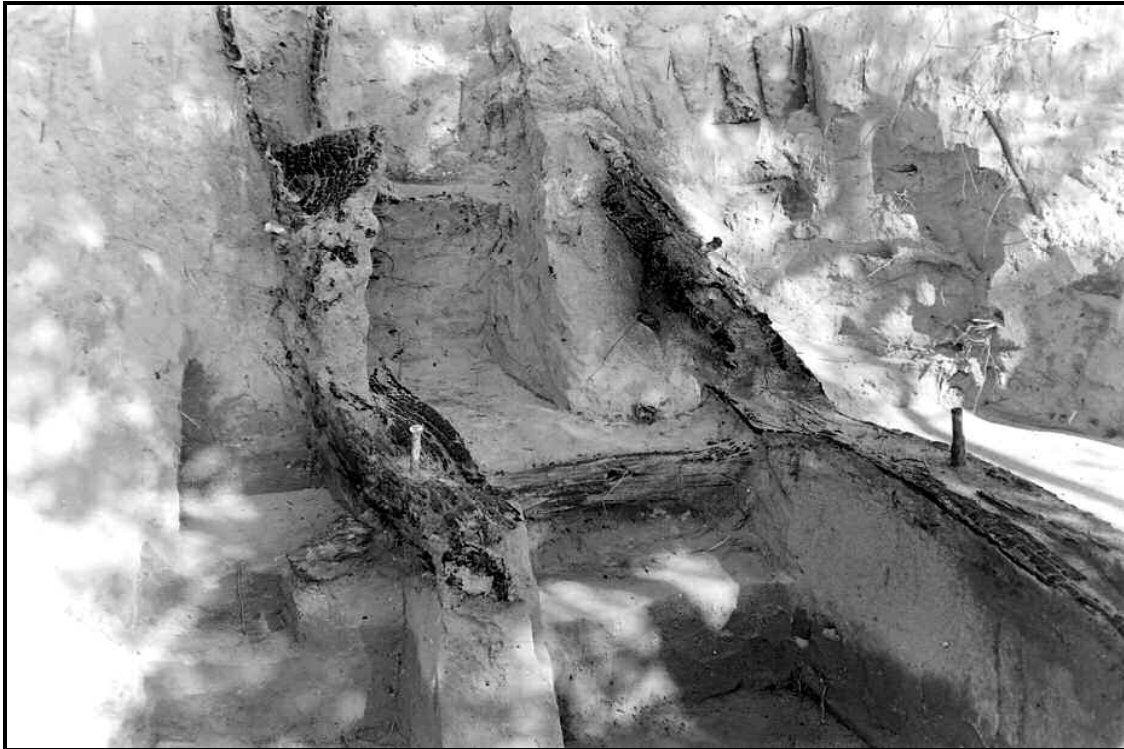
Figure 9: Sills along the entrance section of the bombproof were separated by two spacers dadoed to accept the sills.

With the exception of the northeast wall of the room, all walls were constructed upon 12-inch square pine sills. Sill timbers were laid out in shallow 4-inch trenches and interconnected by 12-inch vertical butt scarfs. Each scarf was fastened by 8-inch wrought iron spikes driven horizontally through the scarf. Where the baffle and corners of the room required altering the orientation of the sill, horizontal 12-inch butt scarfs were employed. A 15-inch long, 1-inch diameter iron pin was driven vertically through the joint at its center to serve both as a fastening and to secure the base of 12-inch square pine corner studs. Along the entrance section of the tunnel the sills were additionally stabilized by two, 4-inch by 6-inch spacers located 7 feet and 19 feet from the entrance tunnel. Both spacers were notched to separate the sills a distance of three feet, and each was situated below the level of the sand floor of the tunnel. No similar spacers were found along the section of the tunnel that extended from the baffle to the room.

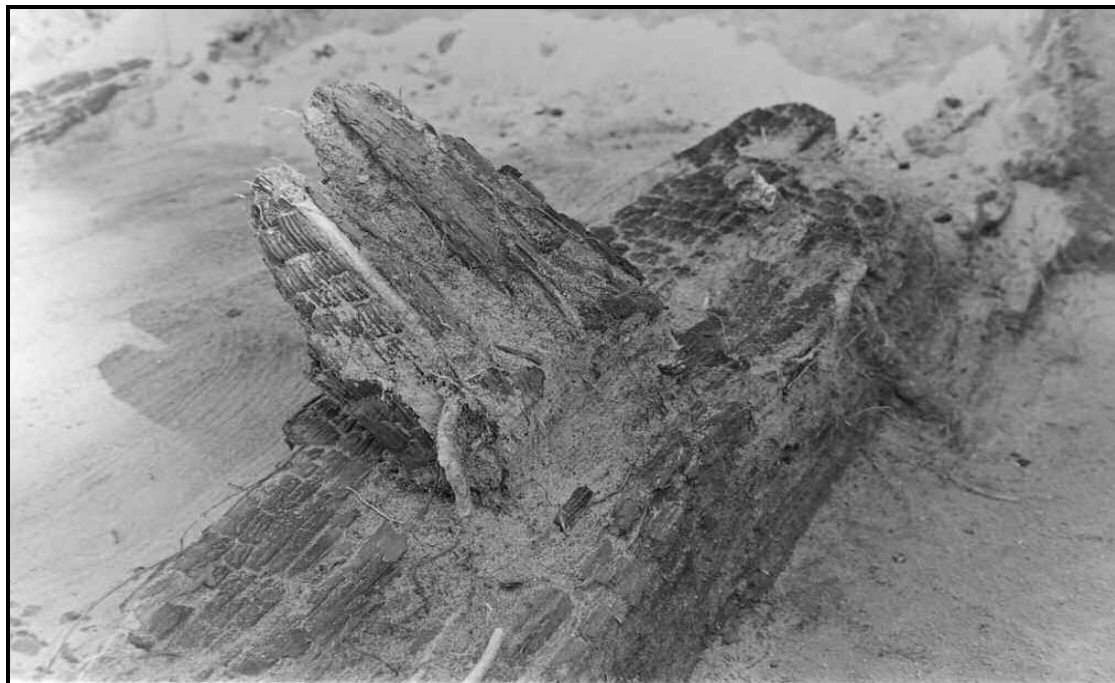
Figure 10: Wall studs along the entrance tunnel were found to have been set into the sills using stopped dado joints.

With the exception of a set of studs, each composed of two 4-inch by 8-inch timbers and located 6 feet inside the entrance of the tunnel, all of the remaining wall studs were found to be constructed from 4-inch by 8-inch pine and positioned on 3-foot centers. Each stud was lap jointed into the exterior face of the sill to a depth of 6 inches vertically and 4 inches horizontally. The top of each stud was pinned to a top plate composed of 4-inch by 8-inch pine. At each stud the top plate was found to have been inletted to accept the ends of 4-inch by 8-inch pine spacers that separated the walls of the tunnel. In the entrance section of the tunnel framing was additionally reinforced by two 14 ½-foot-long, 2-inch by 10-inch pine planks positioned diagonally and fastened to the interior of the framing with 4-inch hand wrought spikes.

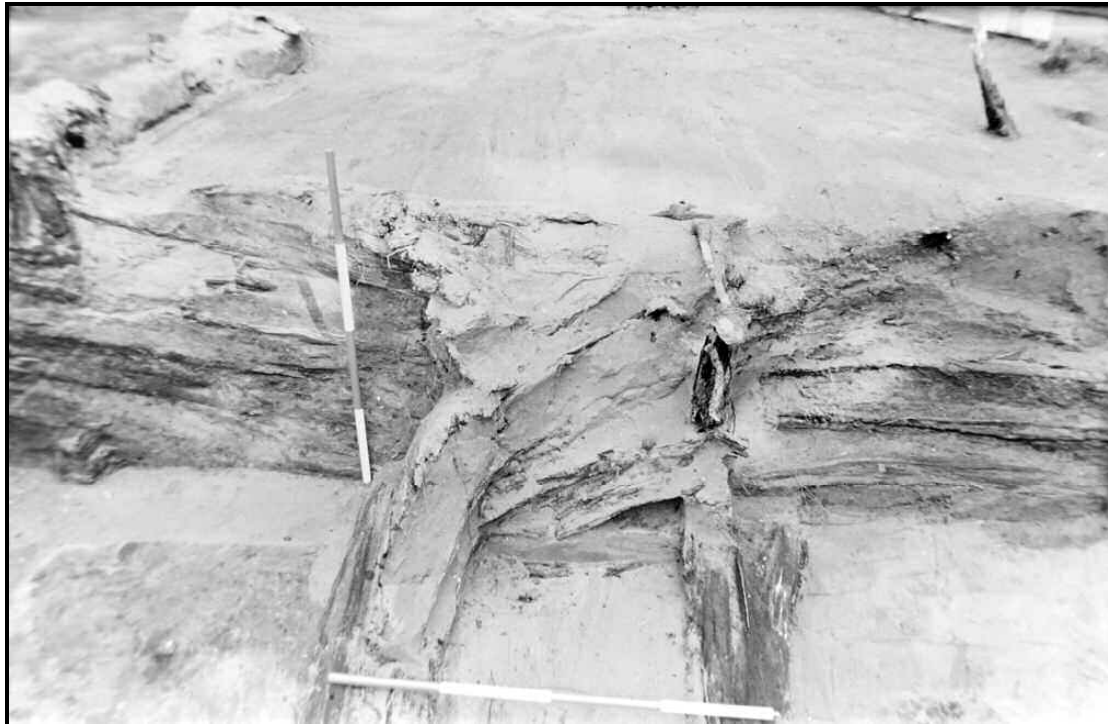
Figure 13: Although the structure had burned and collapsed, sills and portions of the walls of the entrance tunnel and southwest wall of the room remained intact.

The final eight feet of tunnel before reaching the room showed a complete collapse of the eastern wall to the extent of pressing the eastern wall studs and planks against the western wall. The roof of this portion of the tunnel had also collapsed after the east wall had caved in. The interior portions of both walls and the ceiling exhibited evidence of extensive burning.

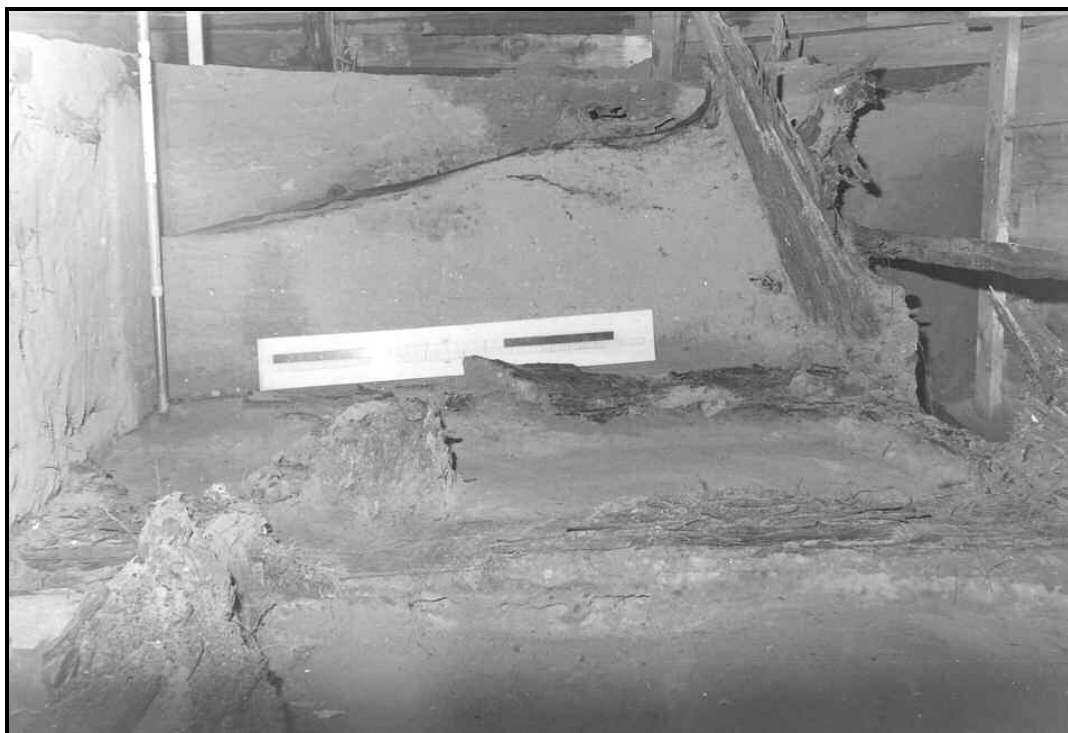
Figure 14: Excavation of the south corner of the bombproof revealed that the roof and walls had partially collapsed into the room once weakened by fire. A layer of charred wood can be seen directly above the original floor level.

The collapse of the bombproof room seems to have been concentrated in the center of the southern half of the room. Only 3 vertical feet of the southern wall was still intact and the roof behind the wall was 2.3 feet above the floor. In places in the southern half of the room the roof beams were less than one foot off the floor. The southern portions of both the east and west walls had buckled into the room. The collapse of these walls was less pronounced in the northern half of the room and at the north wall they were virtually intact. The north wall showed little signs of disturbance. As in the tunnel, the interior faces of the walls and roof beams showed evidence of burning. The heat from the fire escaping up the air shafts was so intense as to cause discoloration of the surrounding sand from yellow to reddish orange.

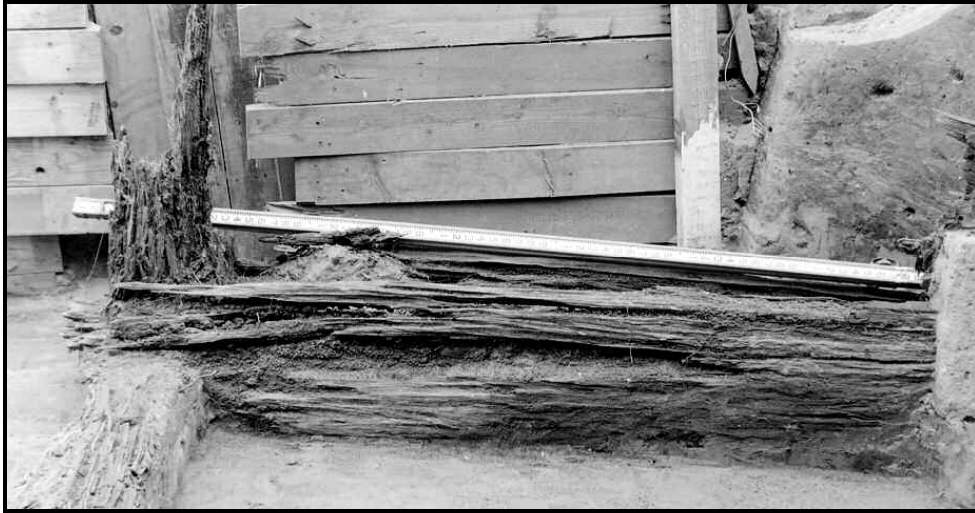
Figure 15: Corner posts were mortised into the overlapping timber of horizontal butt scarfs in the sills.

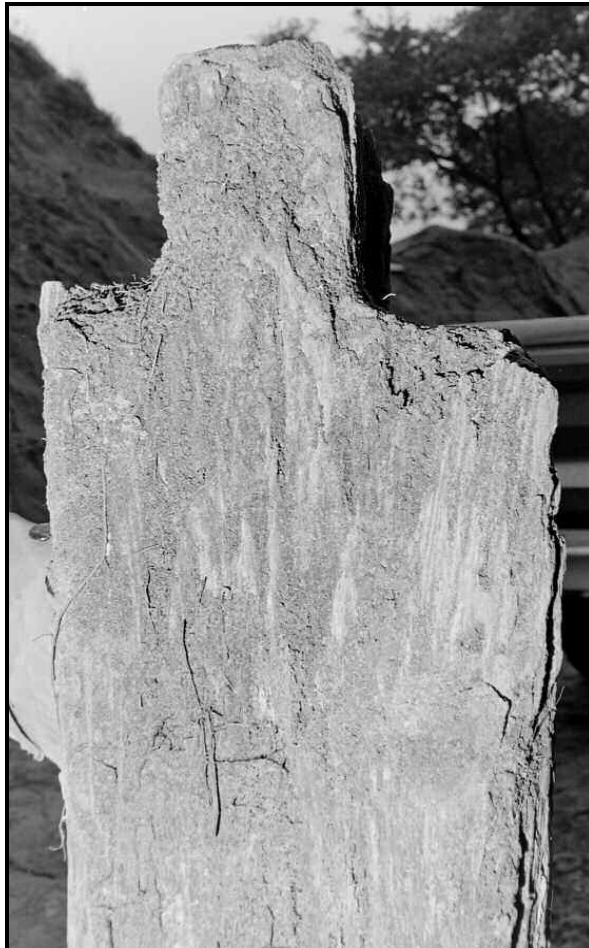
Figure 16: Tenons in the base of the 12-inch by 12-inch studs used in the bombproof wall were found to have been cut on only two sides.

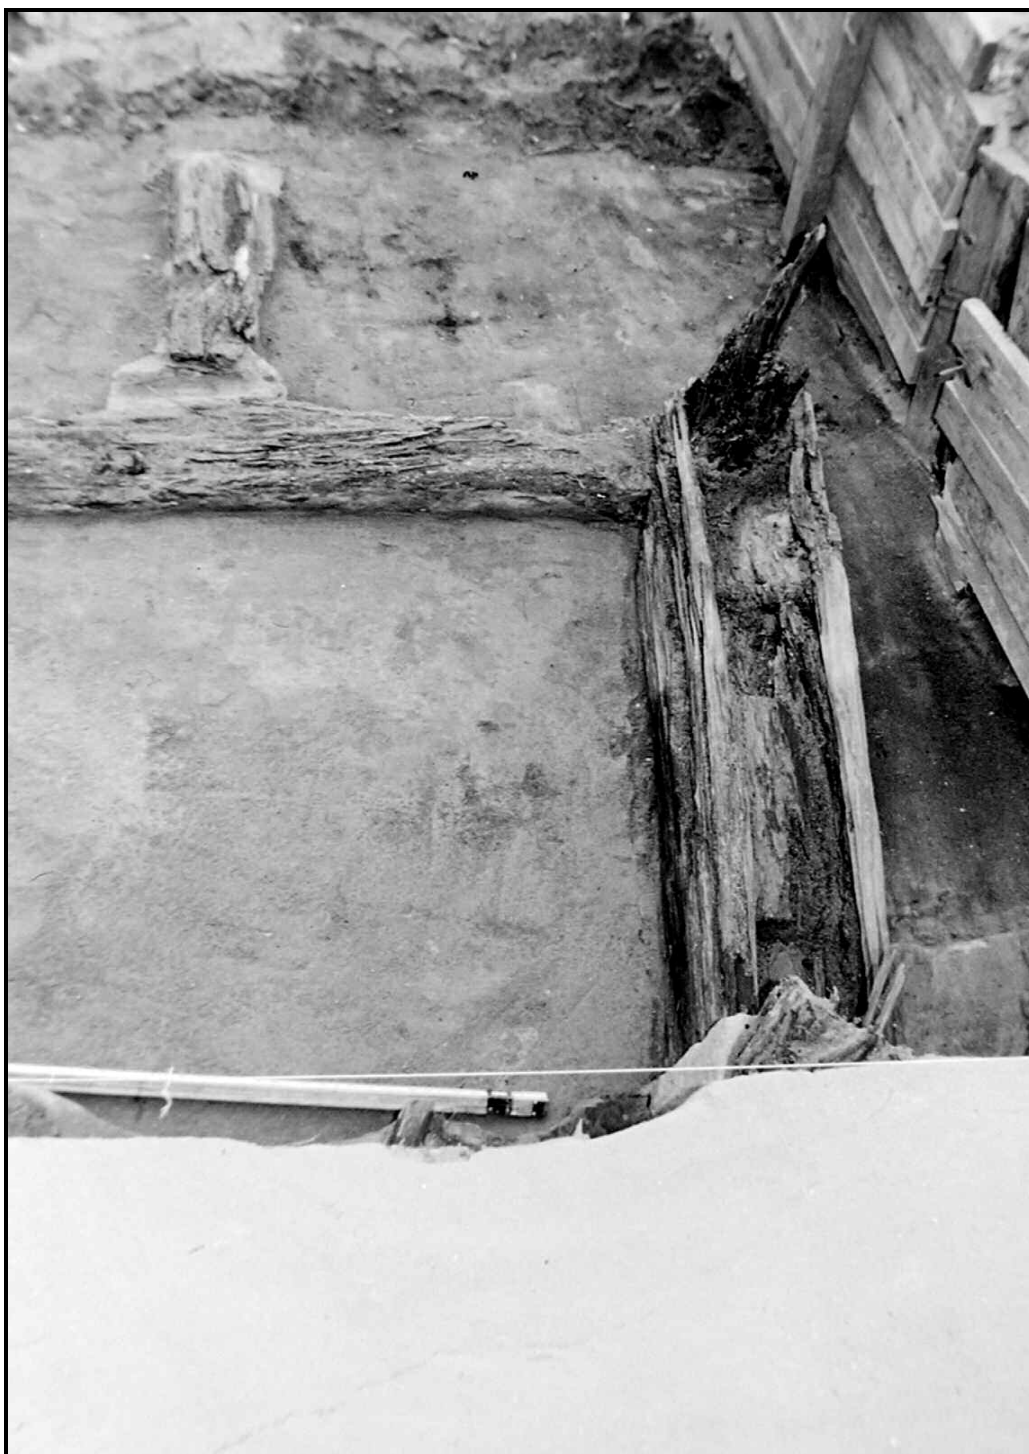
Figure 17: Mortices in the bombproof sills along the northwest wall were obvious once the studs were removed.

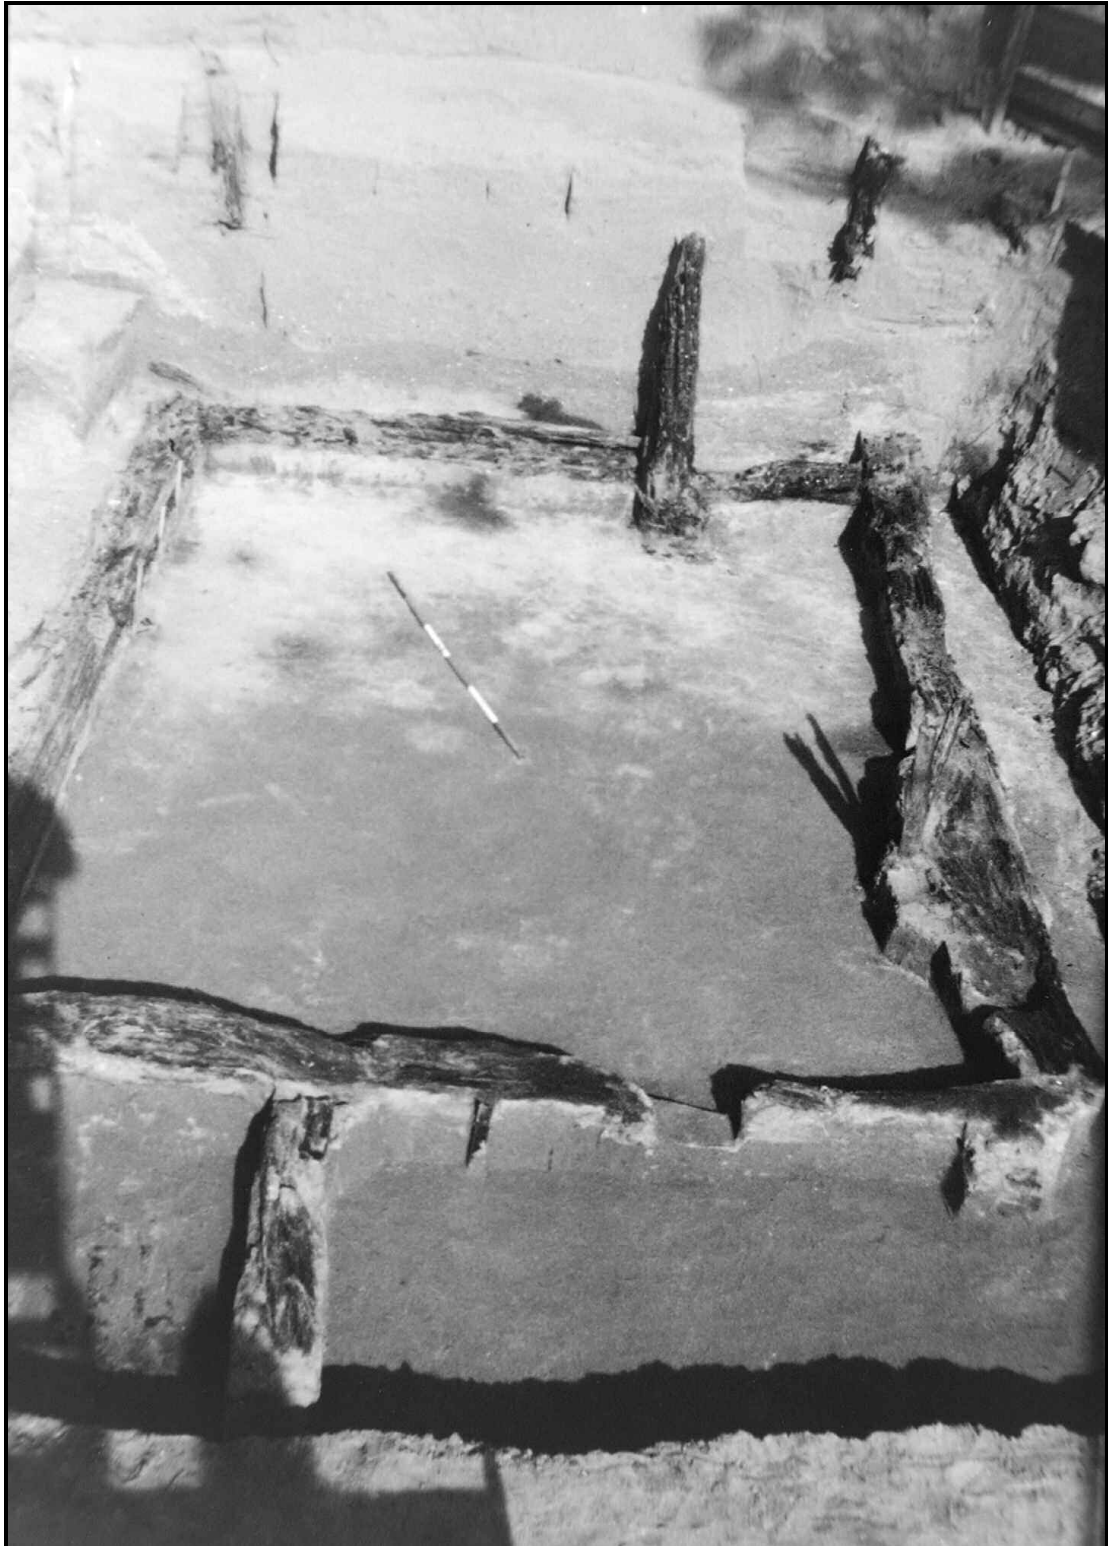
Figure 20: The bombproof sills were cleaned for mapping and photography. Ventilator shafts can be seen in the profile beyond the northeast wall.

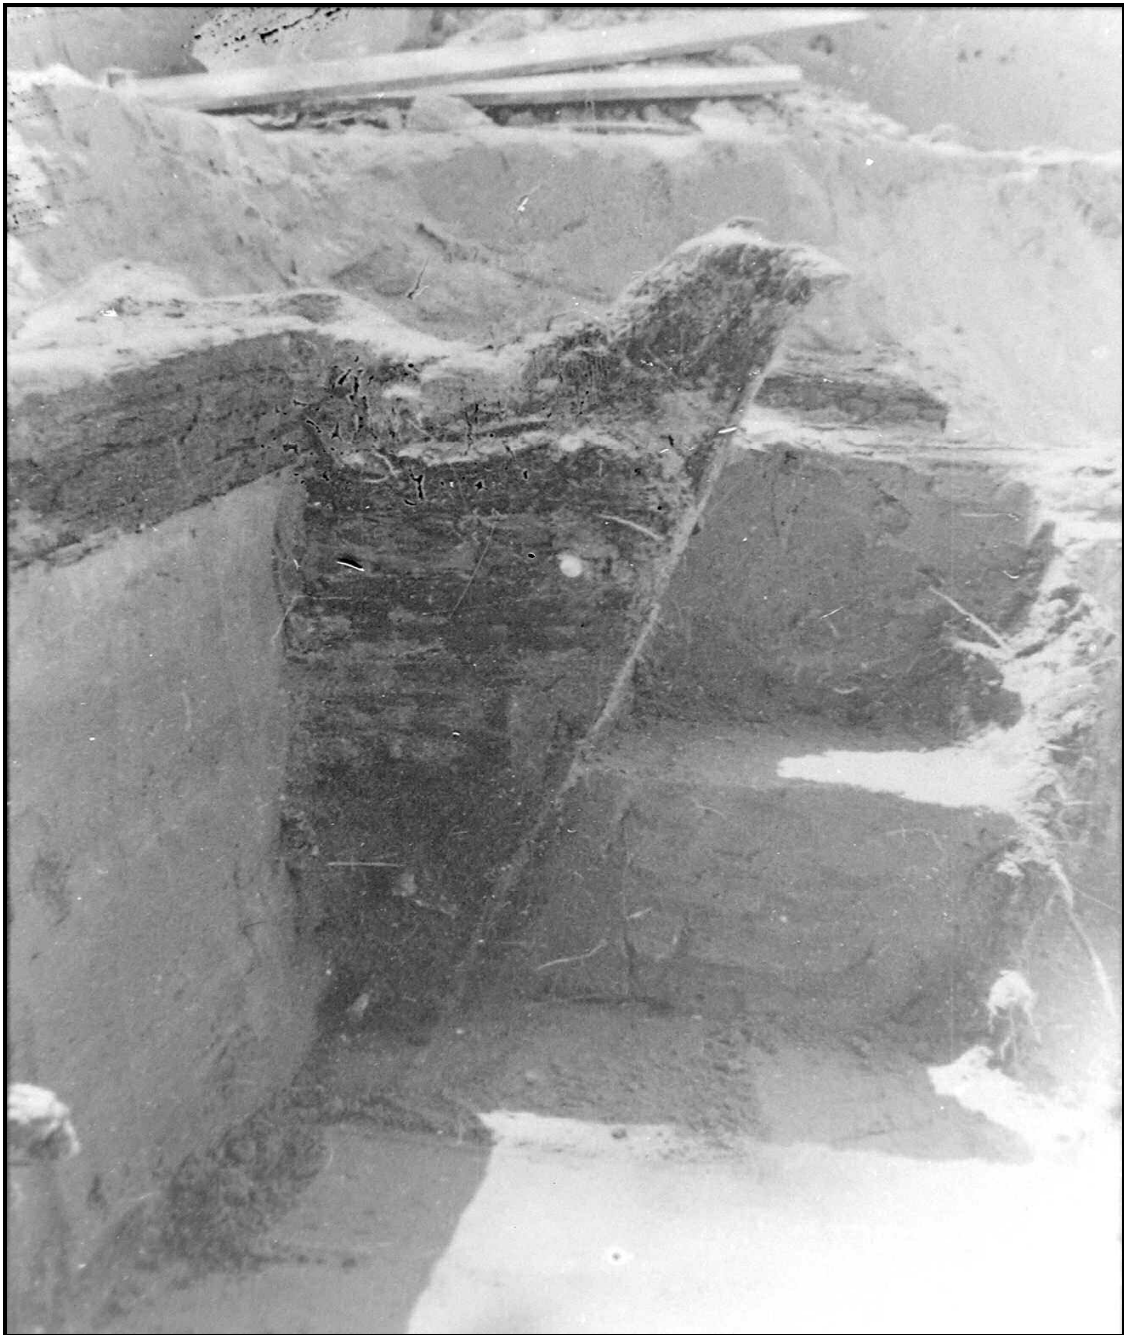
Figure 21: Unmistakable evidence of the interior planking along the tunnel section immediately inside the baffle was found on the east corner post. As was the case along this unusual section, planking was found to be attached at each corner post and studded by one or more 6-inch iron spikes.

The most perplexing aspect of the structure was the interior placement of planking along the first section of the tunnel beyond the baffle. In contrast to using exterior planking, this technique required extensive fasteners to counteract the pressure of fill dirt. This possibly reflected the necessity of building the tunnel within the previously constructed Shepherd's Battery.
